# COMPILATION OF PRESSURE-RELATED INCIDENT SUMMARIES

June 2016 (Rev. 4)

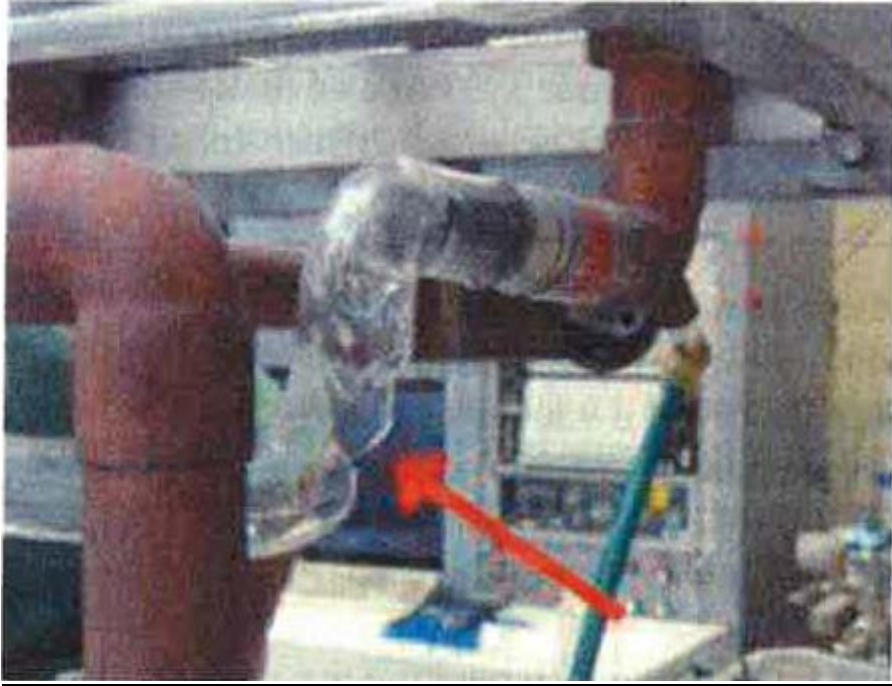
## FAILURE OF A GLASS TUBING VACUUM SYSTEM

04/24/2015. At Pacific Northwest National Laboratory a researcher using a system with glass tubing attempted to backfill the system with ~2 psig nitrogen to relieve a vacuum. She was following a procedure, but was unable to open the system because it was still under vacuum. She increased the nitrogen pressure at the regulator to ~5 psig and tried to open the system again. After she opened the supply valves, a section of the glass pipe failed. The suspected cause was a leaking valve or incorrect valve position.

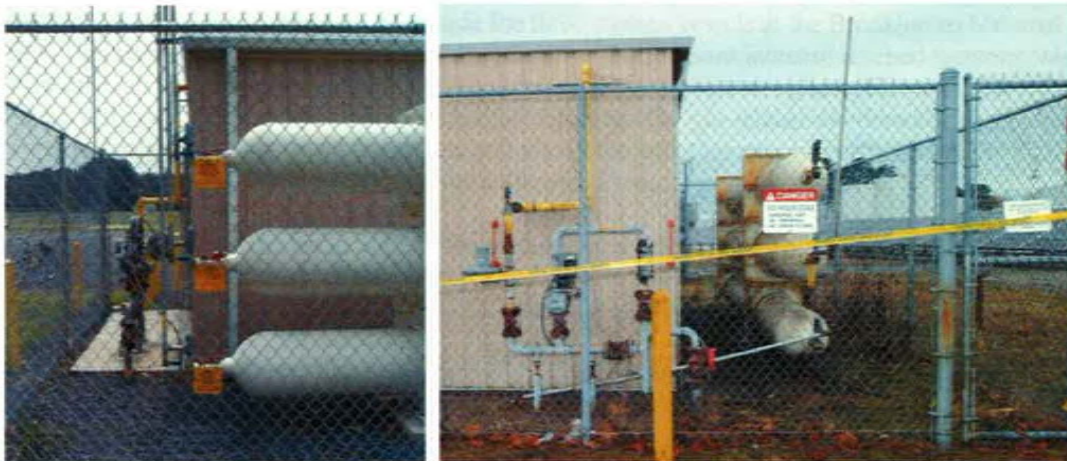
A View of the High Pressure Natural Gas Storage Vessels with the Failed Relief System Before (left) and Aft

On the days leading to January 6, 2014, unusual weather conditions with high temperature variations caused a large pressure rise inside the three storage vessels at the Brookhaven National laboratory (BNL) compressed natural gas (CNG) fueling facility. The pressure increase reached the point where the relief valve on each vessel opened automatically and released gas to the atmosphere. However, the valves experienced valve chatter, were damaged during the event and did not reclose as designed. Furthermore, the discharge piping structure downstream from the relief valves collapsed. Investigation found that the collapsed discharge piping was self-supporting, which is against prevailing code recommendation, and insufficiently braced to resist the reaction forces generated by the high pressure gas discharge.

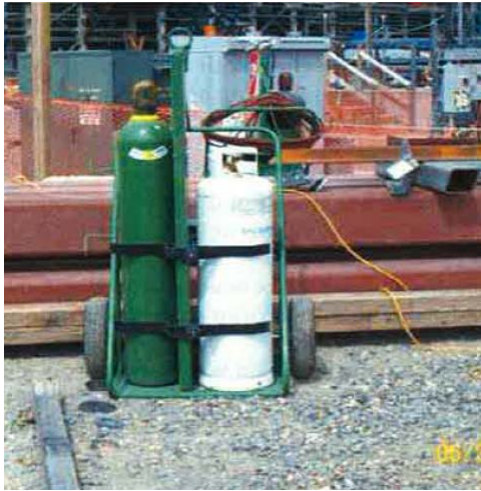
**Storage Truck**

## STARGON GAS CYLINDER KNOCKED OVER SNAPS OFF REGULATOR

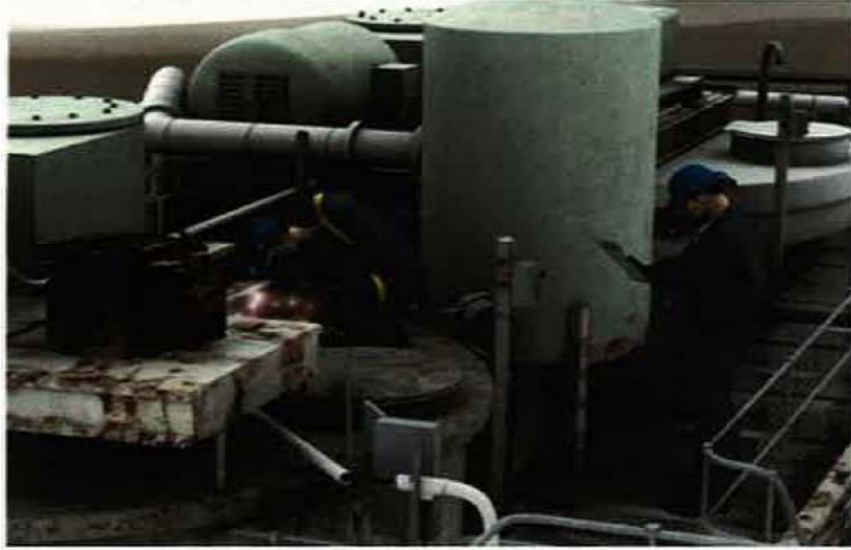
## PRESSURE PIPE EXPLODES IN WELDING ACCIDENT

The plant maintenance staff in a power plant was charged with replacing a high-pressure steam piping spool piece that connects the main steam stop valve to the non-return valve. On the day work began, workers noticed that the main steam stop valve on an adjacent boiler was leaking steam. The workers were unfamiliar with the steam piping arrangement and dismissed its importance. The welders did not perform welder procedure inspections required by the American Society of Mechanical Engineers Piping and Boiler and Pressure Vessel Codes. After the first day of work, the new spool piece was being filled with water and steam because a drain pipe was left closed. When the worker returned the next day for a second pass, the vessel exploded.

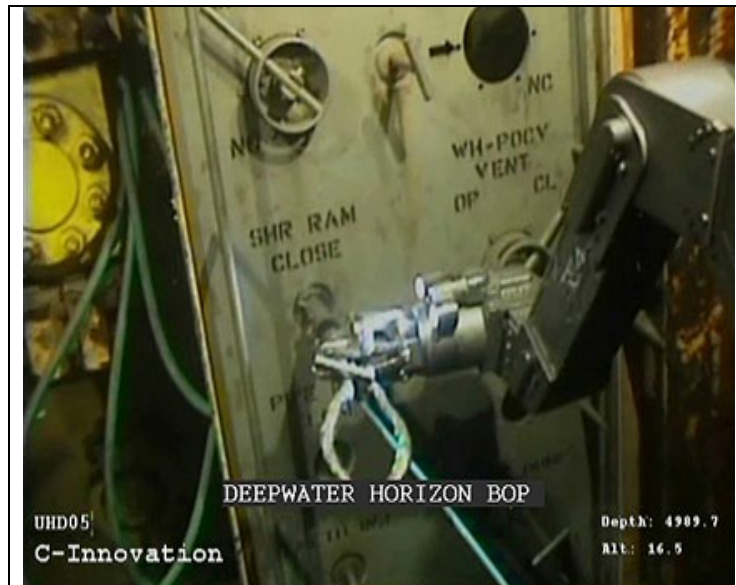
# DEEPWATER HORIZON BLOWOUT PREVENTER MALFUNCTION

In April 2010, the infamous incident occurred in the Gulf of Mexico in which an oil rig failed due to a combination of several factors including a hydraulic leak in the blowout preventer and dead batteries. The incident left 11 workers dead, and incredible environmental damage. The Congressional investigation confirmed that the companies involved had documents that showed there was a leak in the hydraulic systems that operated the blowout preventer, as well as the dead batteries before the accident. Also those documents showed that they ignored the tests that had shown a problem.

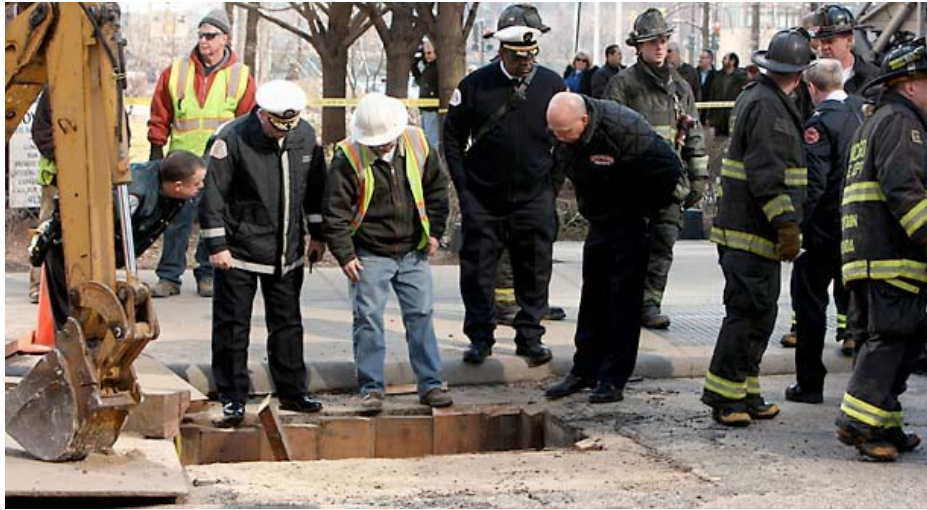
## GAS MAIN ACTS AS PROJECTILE DURING PRESSURE-TESTING

On March 3, 2010, a Peoples Gas **worker died and another was seriously injured** after they were struck by a pipe while pressure-testing an underground gas main. The workers were using compressed air for the test when a section of the pipe moved and struck them.

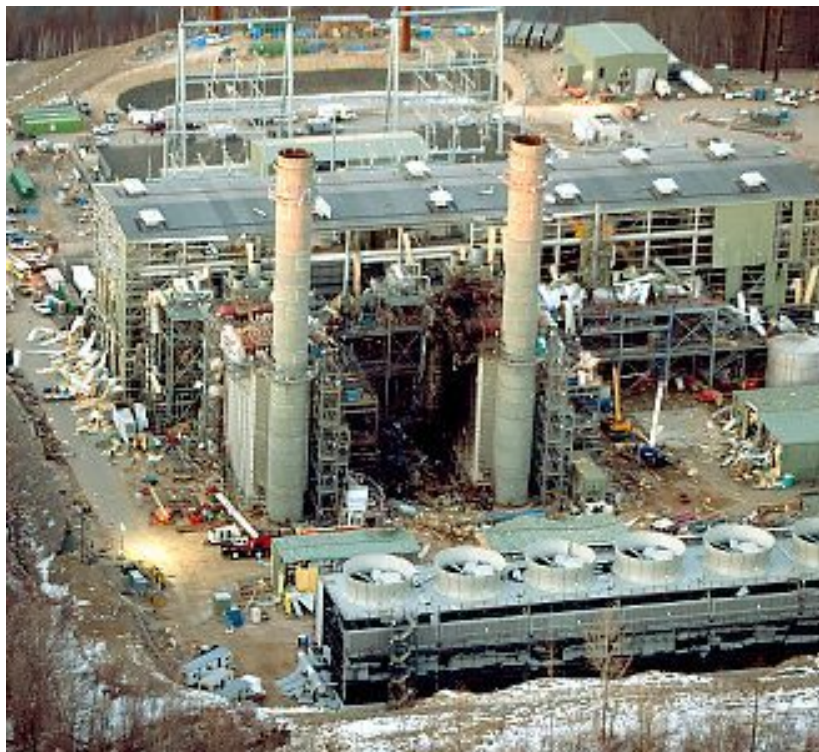
## NATURAL GAS BLOW LEADS TO EXPLOSION

On February 7, 2010, an investigator with the U.S. Chemical Safety Board (CSB) said a natural gas blow might have caused an explosion at a Connecticut power plant that **killed six and injured 26**. The blast happened during a planned blow at the 620 MW Klean Energy Plant during which workers used natural gas at a high velocity to clean debris out of gas pipes. Initial investigations show there was 400,000 standard cubic feet of gas released into an area with two heat recovery steam generators and the wall of the power block building in the ten minutes before the explosion, slowing down the gas' dispersment. With so many construction activities going on at the time, anything could have ignited the gas.

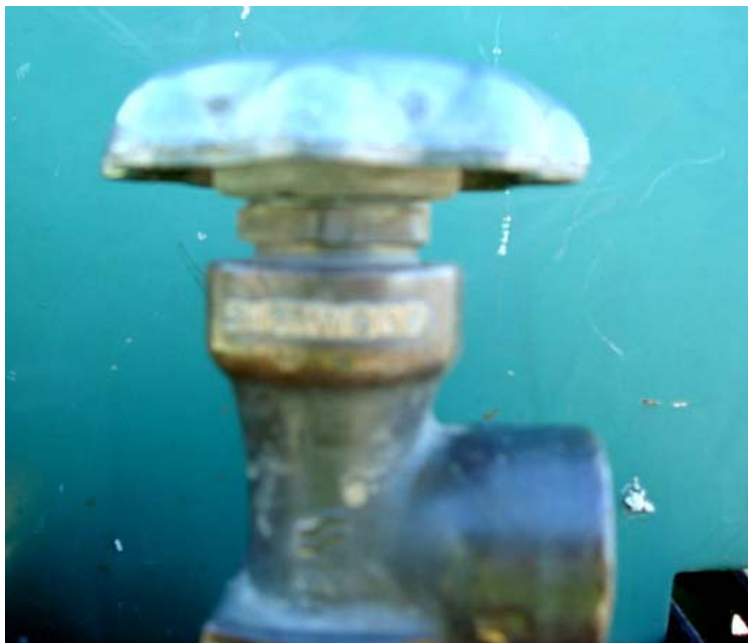
## LEAKING ACETYLENE CYLINDER SHUTOFF VALVES

On January 11, 2010, while cutting rebar with an acetylene torch at the Savannah River Salt Waste Processing Facility (SWPF), a small fire (3-inch flame) occurred at a cylinder shutoff valve, which was quickly extinguished. Investigators determined that the cylinder shutoff valve was leaking at the valve stem when the valve was in the open position. An extensive inspection was conducted on acetylene cylinders at the SWPF. Five out of eight cylinders were found to be leaking just below the handwheel of the shutoff valve. The leaks occurred only when the valves were open. The gas vendor removed the leaking cylinders and provided seven new cylinders; however, three of them also leaked at the same location.

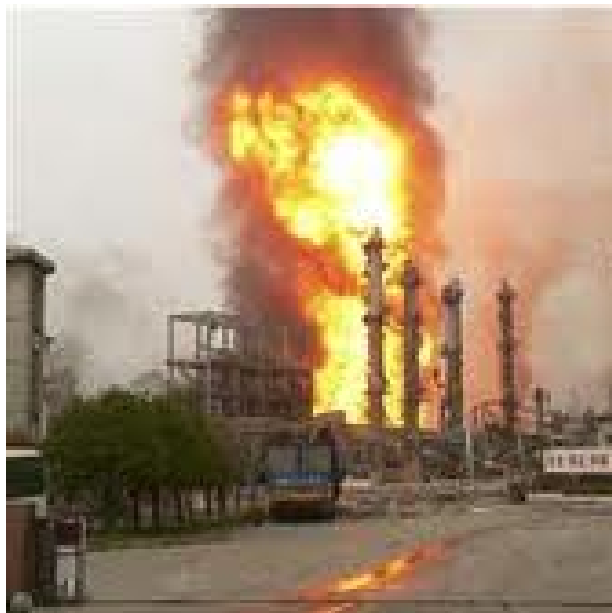
## GAS EXPLOSION IN UTAH

On November 4, 2009, an explosion occurred at the Silver Eagle Oil Refinery in Woods Cross, UT when a 10-inch pipe failed catastrophically. Although the failure mechanism has yet to be determined, the pipe showed evidence of significant thinning, which had not been detected by the refinery's mechanical integrity program. The blast damaged nearby homes and was felt over a distance of several miles. A six-member team CSB led by Investigations Supervisor Donald Holmstrom was deployed to the scene of the explosion, which occurred in the diesel hydro-treater unit. Over the past several days, the CSB team has developed a number of serious concerns about the integrity of the piping and equipment at various locations in the plant. These concerns include a lack of required documentation and a lack of needed calculations of the fitness for service of various pieces of equipment. The agency discussed these serious concerns with Utah OSHA, the Utah Labor Commission, federal OSHA and Silver Eagle executives. CSB Chairman John Bresland told the chairman of the board and the president of Silver Eagle that in his view, the best course of action for the refinery would be to stand down as quickly and safely as possible. The refinery units should remain shut down until the integrity and fitness for service of all the equipment can be documented and verified. Silver Eagle's management responded by beginning an orderly process to stand down the refinery until the steps were accomplished.

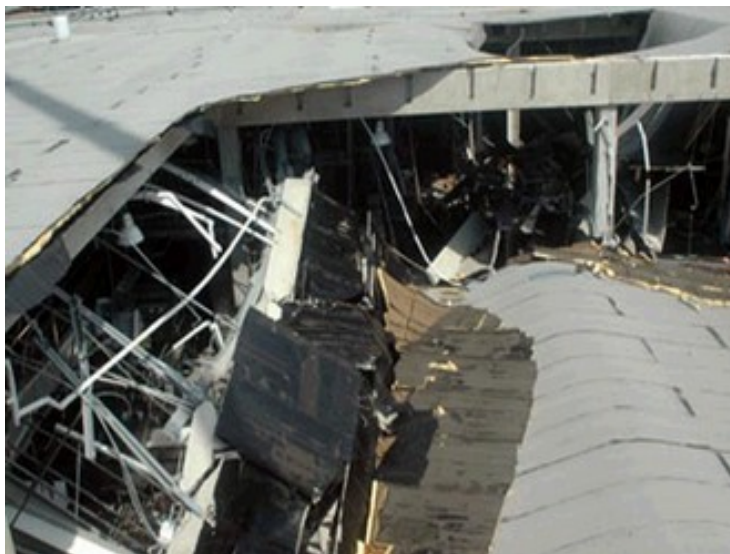
## DEADLY CONAGRA EXPLOSION

On June 9, 2009, a natural gas explosion at the ConAgra Slim Jim production facility in Garner, North Carolina, which **caused four deaths, three critical life-threatening burn injuries, and other injuries that sent a total of 67 people to the hospital.** In preliminary findings, CSB investigators determined that the catastrophic explosion resulted from the accumulation of significant amounts of natural gas that had been purged indoors from a new 120-foot length of pipe during the startup of a new water heater in the plant that made Slim Jims, a popular beef-jerky product. During pipe purging, workers feed pressurized gas into a pipe in order to displace air or other gases so that only pure fuel gas remains in the piping when it is connected to an appliance such as a water heater or boiler.

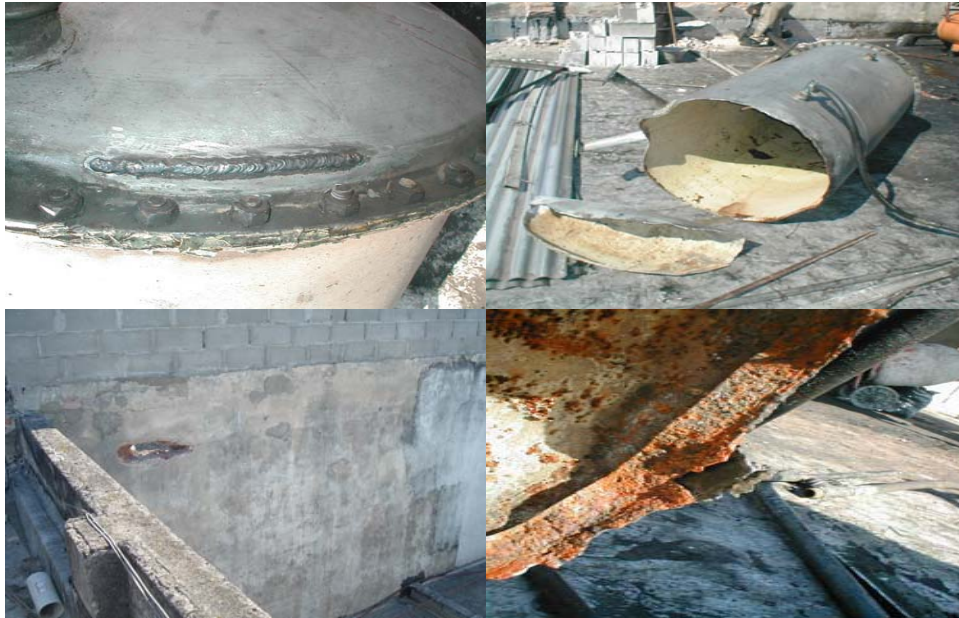
## COMPRESSED AIR TANK FAILURE

In May 2009, a compressed air tank failed, blowing the bottom off of the tank and sending fragments flying into a concrete wall, puncturing the wall. Investigation following the incident revealed several serious problems with the condition of the tank, including severe corrosion and rust at the bottom of the tank, where it failed, and an improper weld repair which had been made to the tank at some time in the past. Although the weld repair did not contribute to this incident, it is a symptom of improper maintenance and inspection, and could have caused a tank failure. Fortunately, nobody was in the area when the tank failed, and there were no injuries.

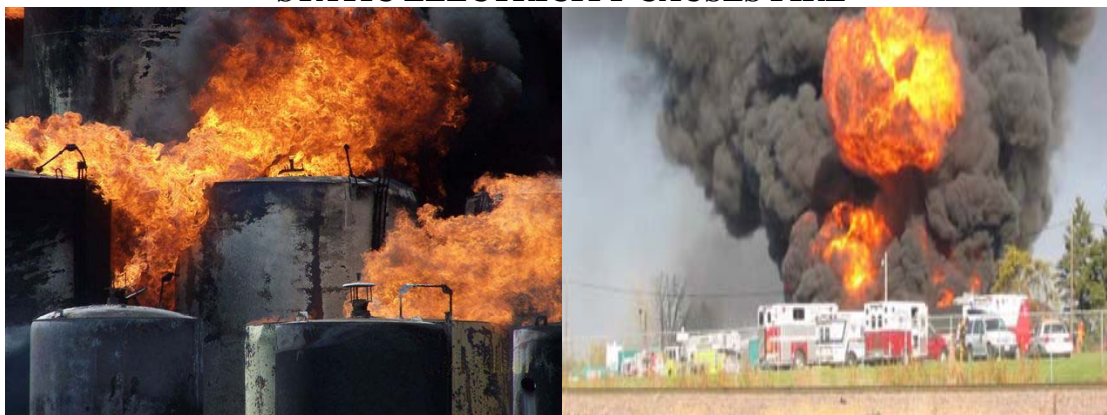
## STATIC ELECTRICITY CAUSES FIRE

At the end of 2008, an incident was published which included a fire starting in a packaging area while a 300-gallon portable steel tank (a “tote”) was being filled with ethyl-acetate. Static electricity was discussed as an ignition source, the importance of bonding and grounding, and the use of dip pipes or bottom loading for filling containers with flammable liquids. In this issue we will discuss another important lesson from the same incident. The consequence of this incident became much more severe because the initial fire spread to an adjacent flammable material storage warehouse. The wall separating the two areas was not fire-rated. Large non-fire-rated doors between the warehouse and packaging area were kept open, and were not equipped with self-closing mechanisms. Also there was no fire protection system (sprinklers or other fire suppression system) in the flammable material packaging area. Spill containment is important whenever you are filling containers with any material, whether flammable or not. For flammable materials, containment helps to limit the area potentially impacted by a fire. And, for all materials containment keeps spills from getting into drains, sewers, surface water drainage, or onto uncontaminated soil. While improper spill containment was not identified as a factor in this particular incident, the incident is a reminder of why containment is important.

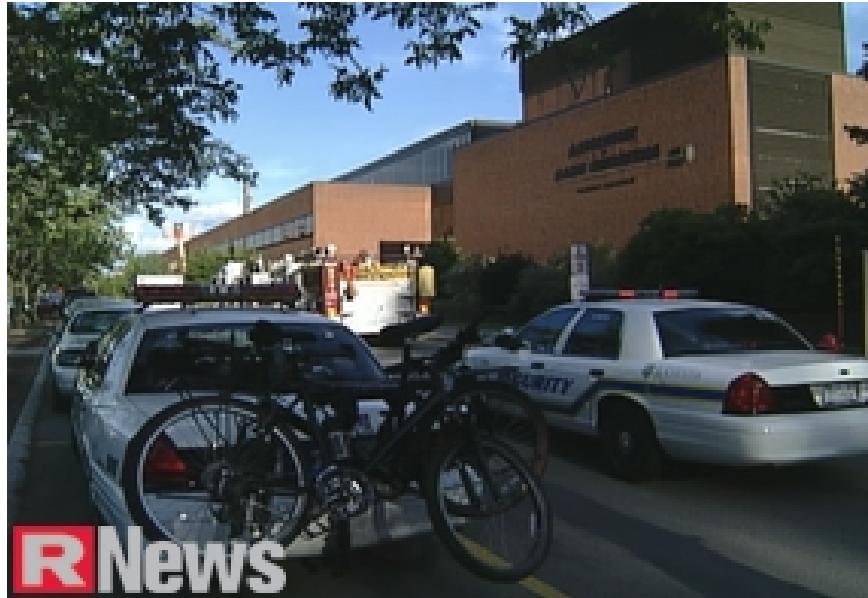
## PRESSURE VESSEL EXPLOSION

On August 6, 2008, a pressure vessel exploded in the Omega Laser Facility at the University of Rochester laboratory. A technician from LLE, Sam Roberts, was seriously injured from the explosion when he was pressurizing the LLNL/LLE GCD light pipe in the target bay, the apparatus collapsed on Sam.

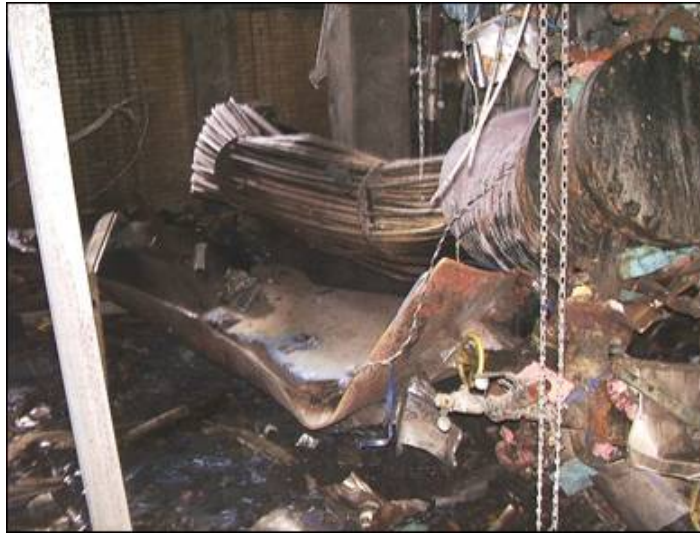
## FATAL RUPTURE OF HEAT EXCHANGER

On June 11, 2008 during a maintenance operation on a heat exchanger, pressurized, liquid ammonia was used to cool chemicals that are later processed to make synthetic rubber. The rubber-making chemicals were pumped through steel tubes inside the heat exchanger, while ammonia flowed through a cylindrical steel shell that surrounded the tubes. The day prior to the accident, the process was shut down for cleaning. During the shutdown, an isolation valve was closed between the heat exchanger and a pressure-relief device designed to protect the heat exchanger from possible over-pressure. On the morning of the accident, an operator used steam to clean out process piping; the steam also flowed through the heat exchanger tubes. The steam heated the liquid remaining in the exchanger shell which caused the pressure to build. With the path to the pressure-relief device blocked, the heat exchanger ruptured over. An operations supervisor, who was not involved in the maintenance work but was working in the area, was **killed** by the explosion. Her body, which was covered with explosion debris, was not discovered until several hours after the emergency had been declared over.

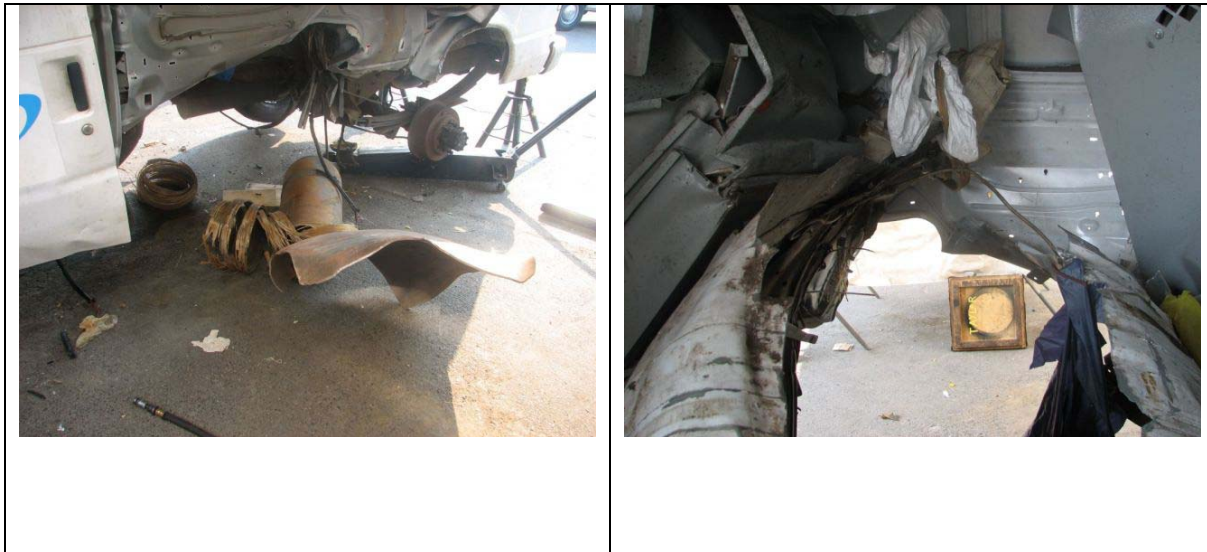
## COMPRESSED NATURAL GAS CYLINDER RUPTURE DESTROYS VAN

On June 9, 2008 the cylinders used to store a van's fuel, compressed natural gas (CNG), ruptured and subsequently caused significant damage to a van. No injuries were mentioned in source. Parts of the van were blown clear of the vehicle, and parts of the cylinder in question were located inside the vehicle's cabin. Moderate damage was caused to nearby vehicles. Investigation yielded corrosion in parts of the cylinder's internal liner, as well as rust from chlorine due to road salt exposure. There were also fractures in the composite liner of the cylinder. There was also evidence to indicate that the pressure in the cylinder was too high because of the malfunction of a pressure limiter in the fueling station the van was refueled at earlier.

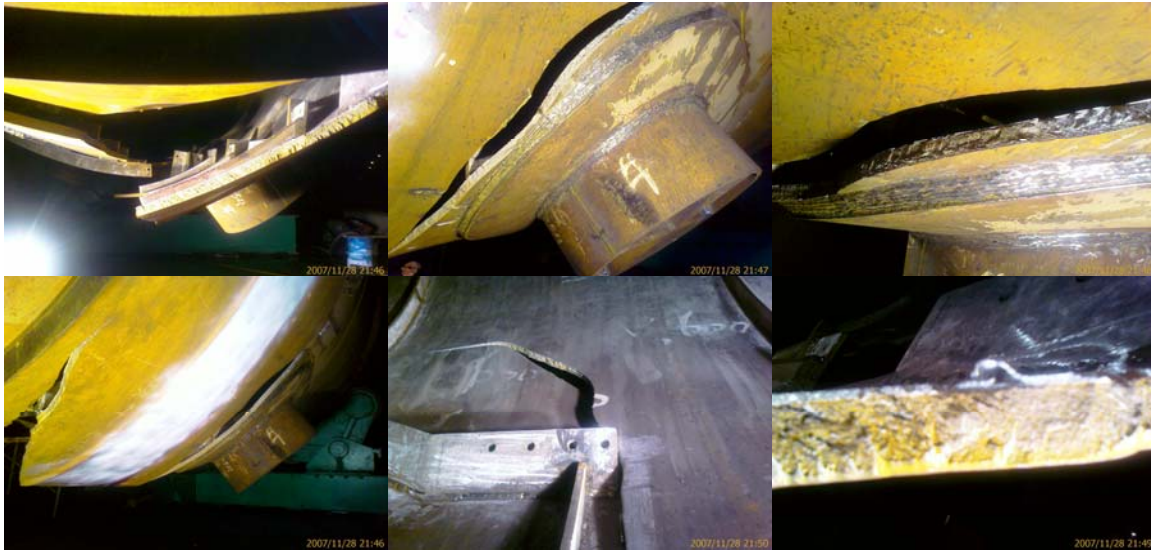
## PRESSURE VESSEL FAILURE DURING HYDROTEST

On November 28, 2007, a pressure vessel failed whilst under hydrotest during post fabrication testing. This vessel was manufactured by a vessel vendor in China and the plate was of Chinese mill origin. Unfortunately this is another example of serious equipment/material failures with equipment being sourced out of the rapidly developing economies such as China, Eastern Bloc and others. These examples are becoming almost a weekly occurrence now and are exhibiting failure modes not seen in the mature manufacturing economies since the 1930's. Again we need to ensure vigilance in the acceptance of manufacturers and once more it is important to know where the base materials are sourced from. Apparently this pressure vessel had reached fifty percent of the required test pressure when the shell ruptured. A metallurgical failure report is not available however from the photographs a number of observations could be made regarding the quality of the material and the welding.

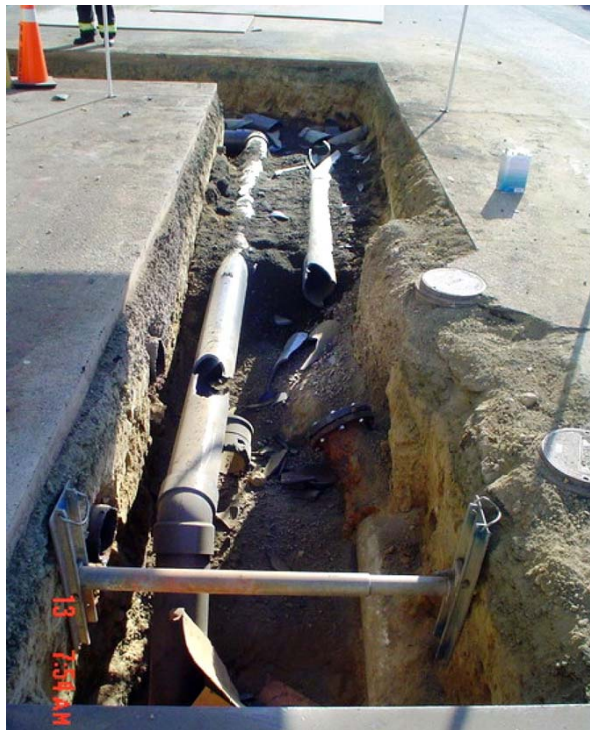
## RESIDUAL FLAMMABLE VAPORS IN PVC PIPE CAUSE EXPLOSION

On September 13, 2007, a subcontractor was implementing a hot tap into a carbon steel pipe. The explosion was caused by the heat from the acetylene torch kindled the residual vapor inside attaching to the polyvinylchloride (PVC) piping. Shrapnel pieces were blown up to 100 feet outwards due to the force of the explosion. The two workers who were closest to the explosion were guarded by an alcove wall. However, the explosion resulted in **four** other **workers**, who were standing 25 feet away, suffering temporary hearing loss.

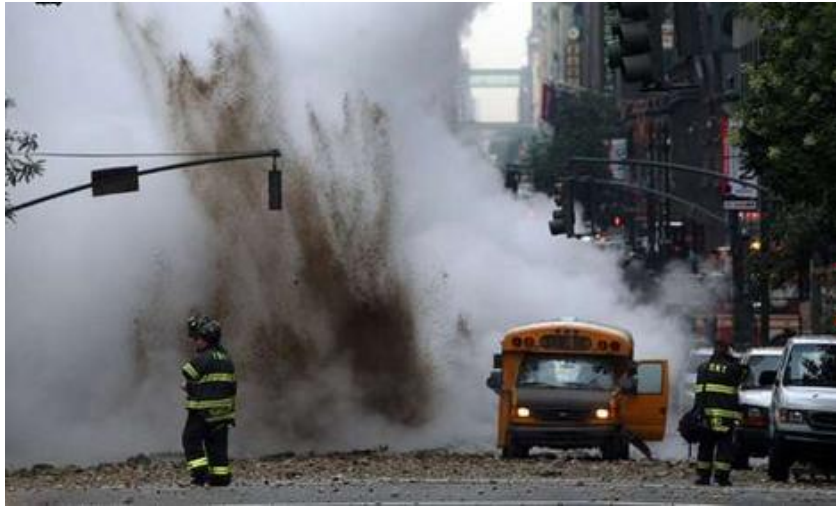
## FATAL STEAM PIPE EXPLOSION

On July 19, 2007, a steampipe explosion sparked the fears of an asbestos contamination in Manhattan, NYC, NY. If there was any asbestos, the steam generated by the water would have washed it down. **One person was killed** (the blast gave him a heart attack) and **twenty others with minor and serious injuries**. Smoke and steam filled the air as the cause of the explosion is still unidentified. This incident produced mass chaos as pedestrians believed it to be another terrorists attack. Con Edison agreed to pay \$24 million to make up for damage.

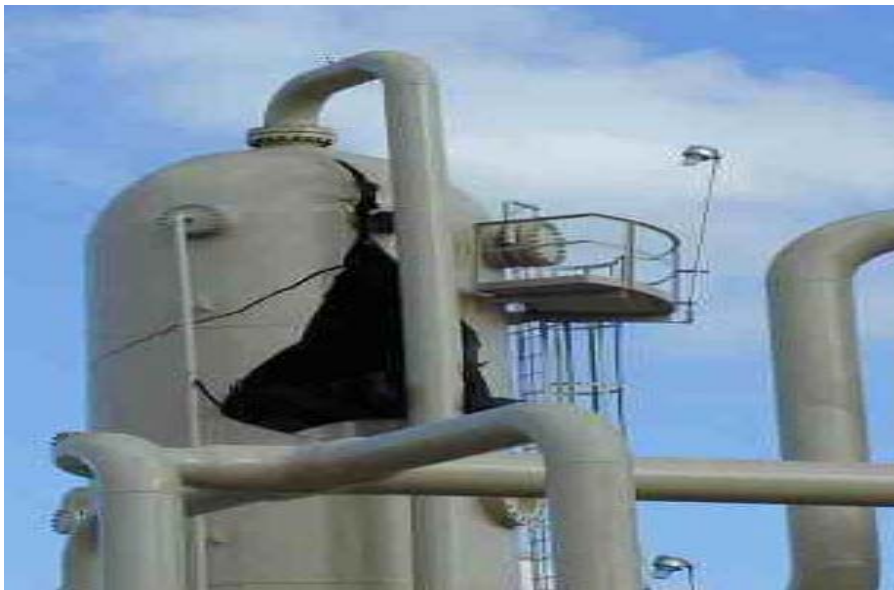
## HYDROSTATIC TEST OF NEW VERTICAL VESSEL

An incident occurred in October of 2002. The cause of the incident is still unknown however the use of “cold water” for hydro-testing could have been a factor. No injuries occurred.

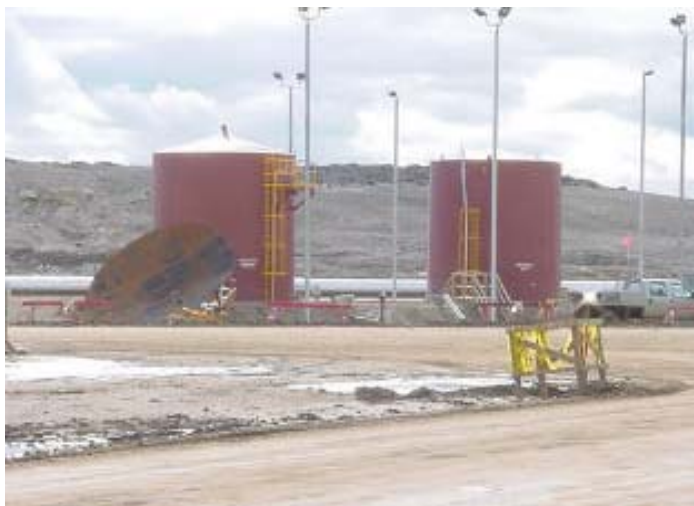
## FILLING OF A VERTICAL TANK

In October 2002, the top of the tank was blown off because the relief valve could not displace the air fast enough for the volume of water that was being pumped in (the filling of the tank was made from a fire hydrant).

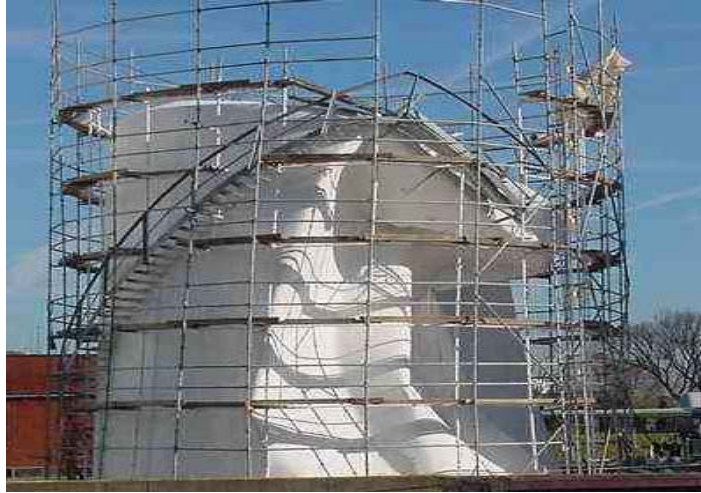
## EMPTYING OF A VERTICAL TANK

In October 2002, the vent was a trapped plastic sheet intended to protect the roof, this caused a vacuum. This incident occurred while the tank was being emptied and this type of incident isn't unusual.

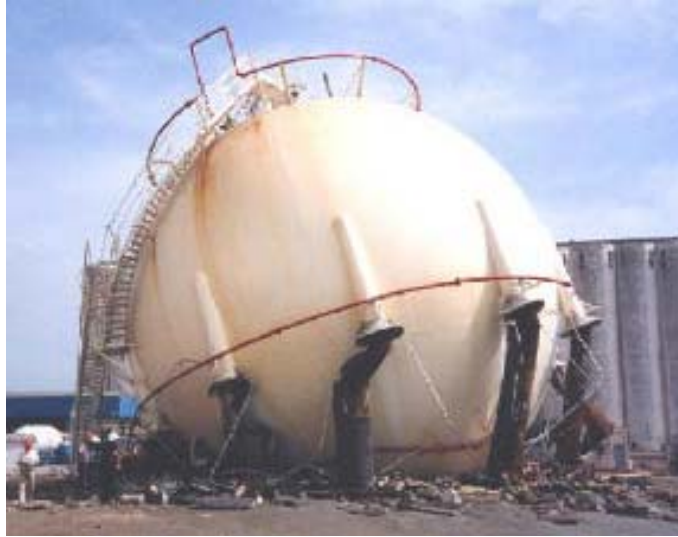
## FATAL SPHERICAL TANK COLLAPSE

During the filling of a 2000m<sup>3</sup> LPG sphere in October 2002, its legs collapsed. The tank was 80% full, killing one and seriously injuring another. The main cause for collapse was the severe corrosion of the legs under the concrete fire protection. The corrosion originated from water ingress between the steel legs and concrete. The poor design of the water caps over the fire-proofing concrete, vertical cracks, poor repairs, and salt water testing were contributing factors to the cause of the collapse. **One person was killed and one seriously injured.**

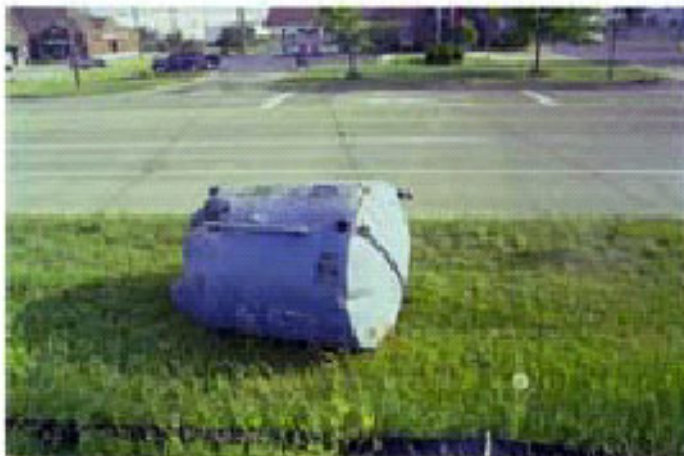
## FATAL EXPLOSION OF PRESSURIZED TANK

On June 21, 2001, a 39-year old male **died** when a 500-gallon storage tank he had started to empty of waste oil and water exploded from its base striking him in the head. He had vacuumed the waste oil and water into the tank from a trench on the other side of the plant and transported it with a lift truck to the underground waste storage area for disposal at a later time. He was pressurizing the contents of the tank with air from a compressed airline located just inside the plant to speed the evacuation of the waste oil and water into the waster storage area. The tank was not approved for use as a pressurized vessel. Fittings on the tank had been adapted for the purpose of connecting them to the compressed airline. The force of the explosion propelled the tank 500 feet in the air over the plat fence and a nearby bank parking lot onto a bust east/west road. This was a maintenance task that had been conducted in this manner for over 6 years. No one witnessed the actual event. Statements from nearby workers and maintenance staff were relied upon to reconstruct what was presumed to have occurred. The deceased was found lying near the place where he had been last seen beginning to drain the tank. Emergency personnel confirmed that he was dead when they arrived at the site.

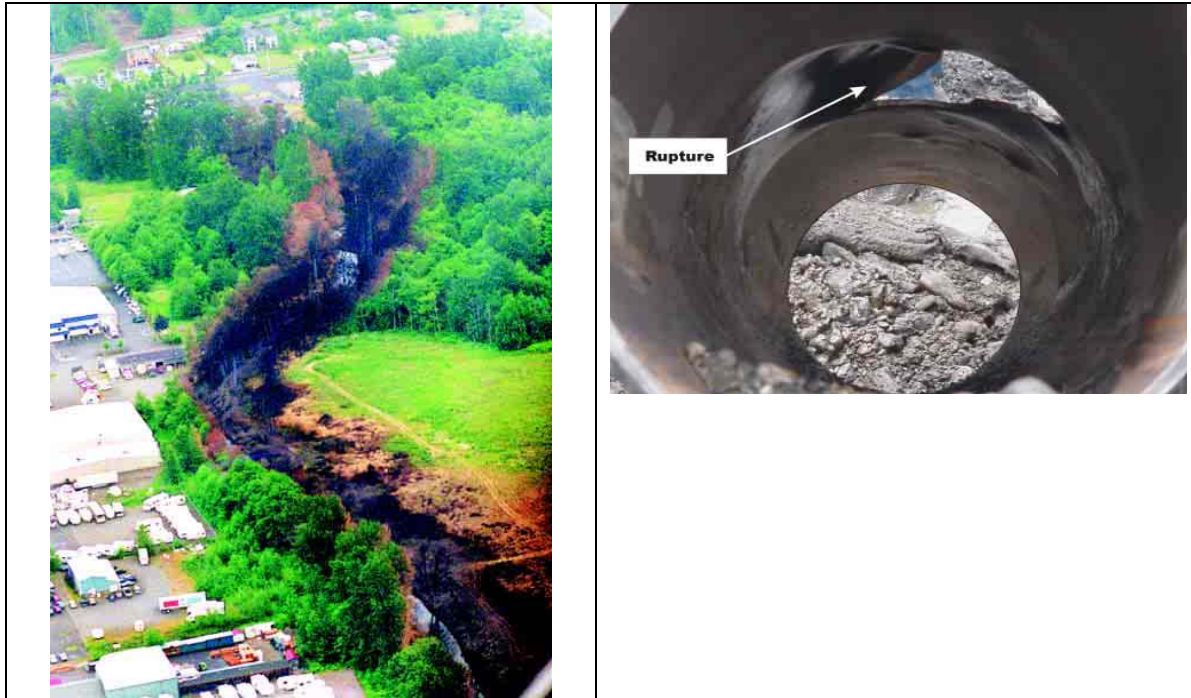
## 16-INCH PIPE'S LEAK CAUSES 1.5 MILE-LONG FIRE

On June 10, 1999 an oil pipeline ruptured releasing a large amount of gasoline into a creek in Bellingham, Washington. Approximately 90 minutes after the rupture the stream of oil ignited. This caused damage for 1.5 miles along the creek, and killed 3 people. One factor that contributed to this accident was a faulty repair job done in 1994 that weakened the pipe in the first place. A proper inspection of the pipeline could have noticed this damage. Also the control system malfunctioned at the time of the crisis requiring the people running it to switch to a back-up system. Unfortunately not all the information from the primary control system was transferred to the secondary system resulting in confusion among the people in charge.

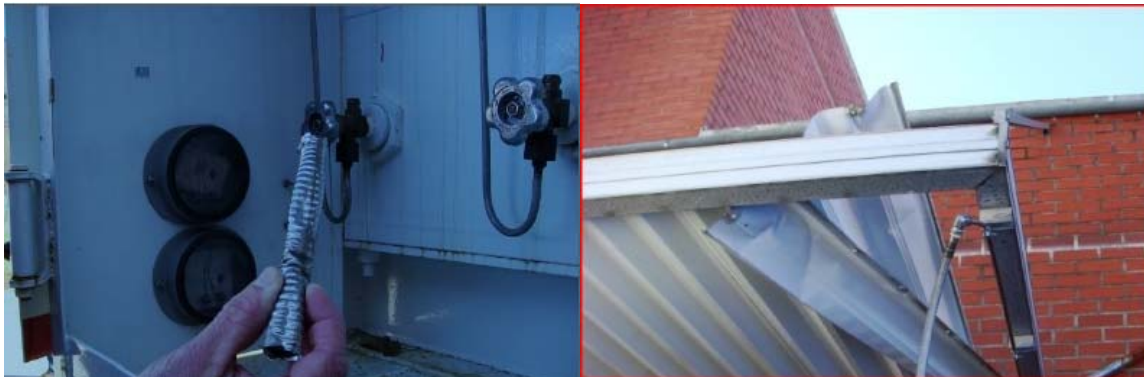
## FLEXIBLE METAL HOSE ASSEMBLY FAILURE

An ORNL researcher requested installation of a new argon gas line which would provide a continuous operation of uninterrupted supply of high-purity grade of argon gas for ultra-trace level metal analyses. At the time, an existing copper line had been used for nitrogen gas; the other line was an insulated line used for liquid nitrogen. The researcher suggested that the existing copper line be replaced with stainless steel for argon. The research staff member, task leader, and parts supplier representative participated in a walkthrough of the area and discussed what materials would be needed for the installation of the new argon line. A maintenance work plan was written to replace the copper tubing with stainless steel tubing for the argon supply. Funding delays necessitated that a new plan be written several months later. The new work plan included additional overhead work involving existing plumbing in the laboratory; installation of a pressure regulator on the argon supply manifold, and reconnection of the argon supply piping system (i.e., existing flexible metal hose assembly) to the argon tube trailer outside the building. To complete the work plan, two pipefitters reinstalled a pressure regulator on the building argon supply manifold and reconnected the argon supply piping system (i.e., existing flexible metal hose assembly) to the argon tube trailer outside the building. To leak test the reinstallation of piping, the workers slowly pressurized the system to 2100 PSIG using the needle valve located on the tube trailer. Workers applied 2100 PSIG to the flexible metal hose assembly and maintained it at that pressure for 3 to 5 minutes prior to workers initiating leak testing. Approximately 5 minutes after pressurizing the line and while the workers were performing the leak testing of piping joints, the flexible metal hose assembly failed near a fitting attached to the tube trailer. The flexible metal hose assembly struck one worker on the forehead resulting in a small cut and struck a second worker on his left hand. Medical services sent the **worker with the forehead injury** to a local hospital as precautionary measure. Local medical services evaluated the second worker on-site. Off-site and local medical services evaluated, treated, and released both employees.

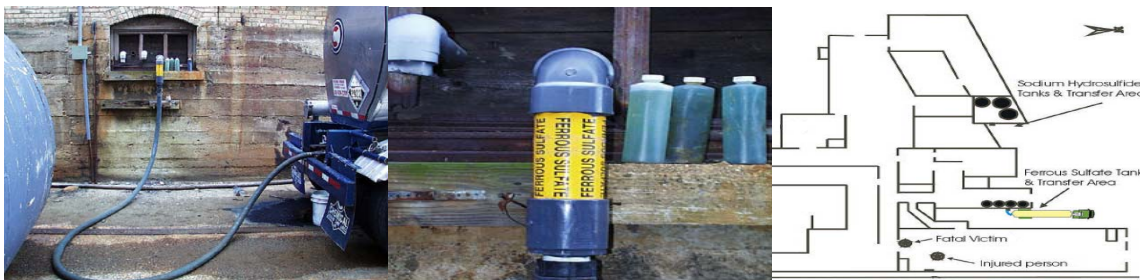
## FATALITY CAUSED BY UNLOADING THE WRONG CHEMICAL

A truck of sodium hydrosulfide-solution arrived at a factory at about 3:30 AM, and was to be unloaded to a storage tank in the area near the top center of the diagram (right picture above). The truck driver had never been to the plant before, and asked the plant shift supervisor for assistance. The shift supervisor had been told to expect a chemical shipment, and assumed that the chemical would be ferrous sulfate, which is the only chemical that he had ever received on his shift. He directed the truck driver to the unloading station for ferrous sulfate, where the truck is shown in the diagram. The shift supervisor did not verify the identity of the chemical in the truck, although the shipping papers did properly identify the contents as sodium hydrosulfide. The supervisor signed the shipping papers without reading them and left the area. No plant employees remained in the unloading area. The truck driver connected his truck to a hose which was connected to the ferrous sulfate storage tank as shown in the photographs. He began to unload the sodium hydrosulfide solution into the ferrous sulfate tank. Unfortunately, sodium hydrosulfide and ferrous sulfate react to form hydrogen sulfide, a highly toxic gas. Shortly after the unloading began, a plant employee in the basement of the building noticed a pungent odor and lost consciousness. He regained consciousness and made his way outside where he got help from other employees, who called emergency response personnel. They found the truck driver unconscious inside the building, and he was **pronounced dead at the scene**. He was determined to have been overcome by hydrogen sulfide gas.

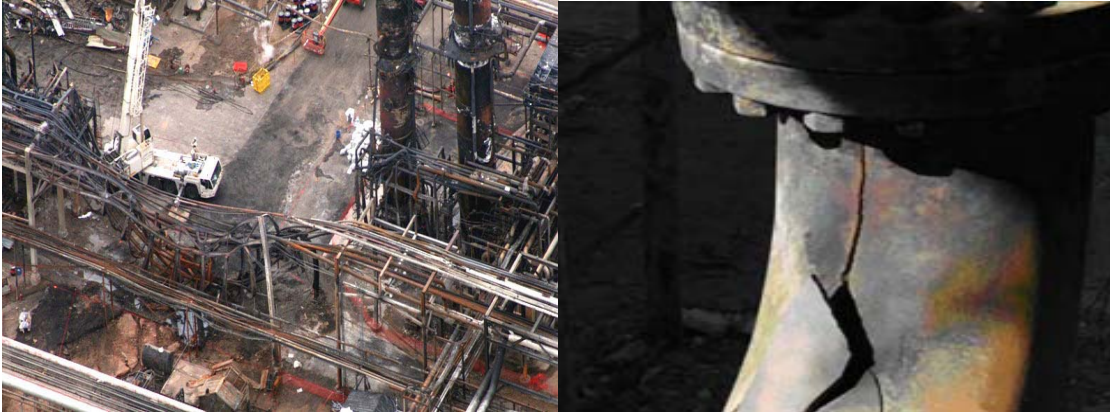
## ICE RUPTURES UNUSED PIPE AND CAUSES FIRE

A section of piping in a refinery unit was taken out of service during a process modification. The unused piping was not physically removed, nor was it isolated from the active piping with slip blinds. Instead, it was isolated from the connected piping by closed isolation valves. The active piping contained liquid propane under high pressure, and the propane contained a small amount of liquid water entrained as a separate water phase. Debris jammed in the seat prevented one of the isolation valves from closing fully. This allowed wet liquid propane to leak from the active piping into the unused piping. The water, which is heavier than propane, accumulated at a low point in the unused piping. During the winter, the water which had accumulated in the unused piping froze. When water freezes it expands, and this expansion caused a crack in the unused pipe. When the weather warmed, the ice melted and propane leaked from the active piping through the leaking isolation valve, and then out through the cracked pipe. A large flammable vapor cloud formed and ignited. The resulting fire caused **four injuries**, the refinery had to be evacuated, and it was shut down for nearly two months. The fire caused major damage to other equipment and piping, resulting in additional release of flammable materials and escalation of the fire. More than two tons of chlorine was also released from containers impacted by the fire.

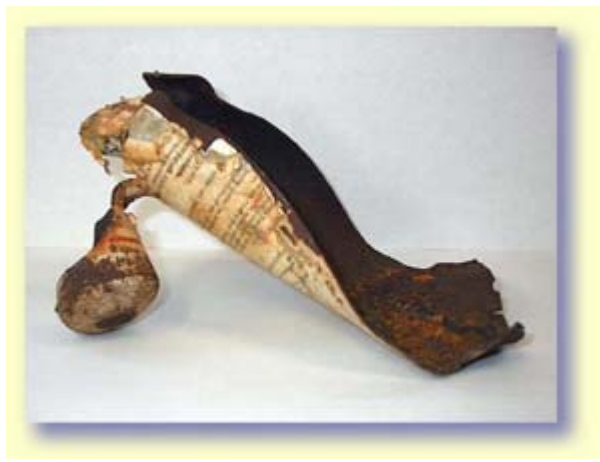
## GAS CYLINDER EXPLODES AT UNIVERSITY

At an unknown date a gas cylinder that contained hydrogen fluoride exploded in a University of California laboratory. The speculated cause of the explosion was that the hydrogen fluoride reacted with the metal container it was in, slowly forming iron fluoride. This weakened the inside of the cylinder until it finally gave way. The shelf life for cylinders storing HF is one to two years. The cylinder in question was at least seven years old.
